Docket No. 217 – Development and Management Plan Inspection

Northeast Utilities Service Company Certificate of Environmental Compatibility and Public Need for the construction of a 345-kV electric transmission line and reconstruction of an existing 115-kV electric transmission line between Connecticut Light and Power Company's Plumtree Substation in Bethel, through the towns of Redding, Weston, and Wilton, and to the Norwalk Substation in Norwalk, Connecticut.

Date: December 30, 2005

Location: Transition Stations: Hoyts Hill, Archers Lane, Norwalk Junction

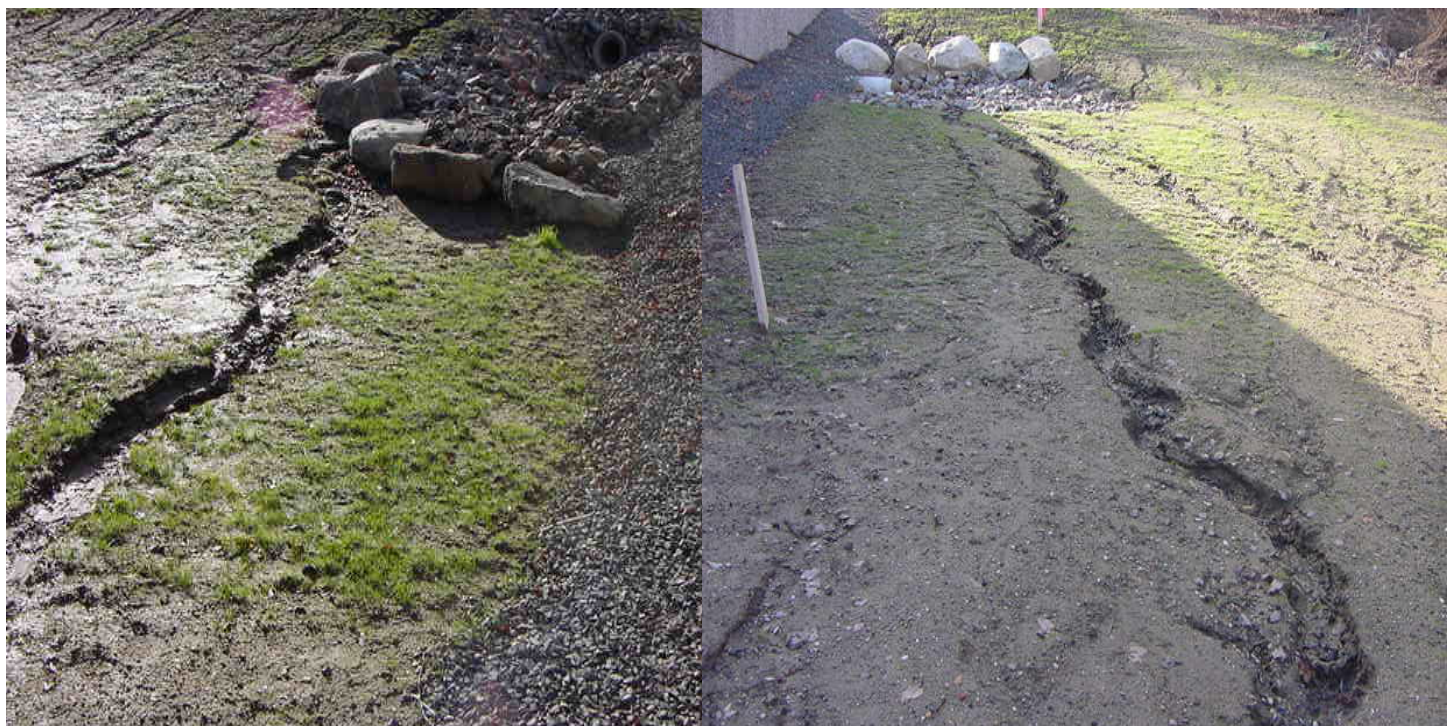
Hoyts Hill Transition Station: Both photos show views of the gullies to the north and south of the station pad. Sedimentation continues along the silt fence as a result. 12/30/05

Foundation construction	<p>- The Hoyts Hill station yard has been backfilled and brought to grade. Final grades are not complete along the wetland edge due to future work here. 11/17-12/30/05.</p> <p>- Additional work may be necessary on the outlet/dissipater pads as</p>	<p>-None at this time. 12/30/05.</p> <p>-The pads may need to be extended based on the noted erosion issues. See erosion</p>

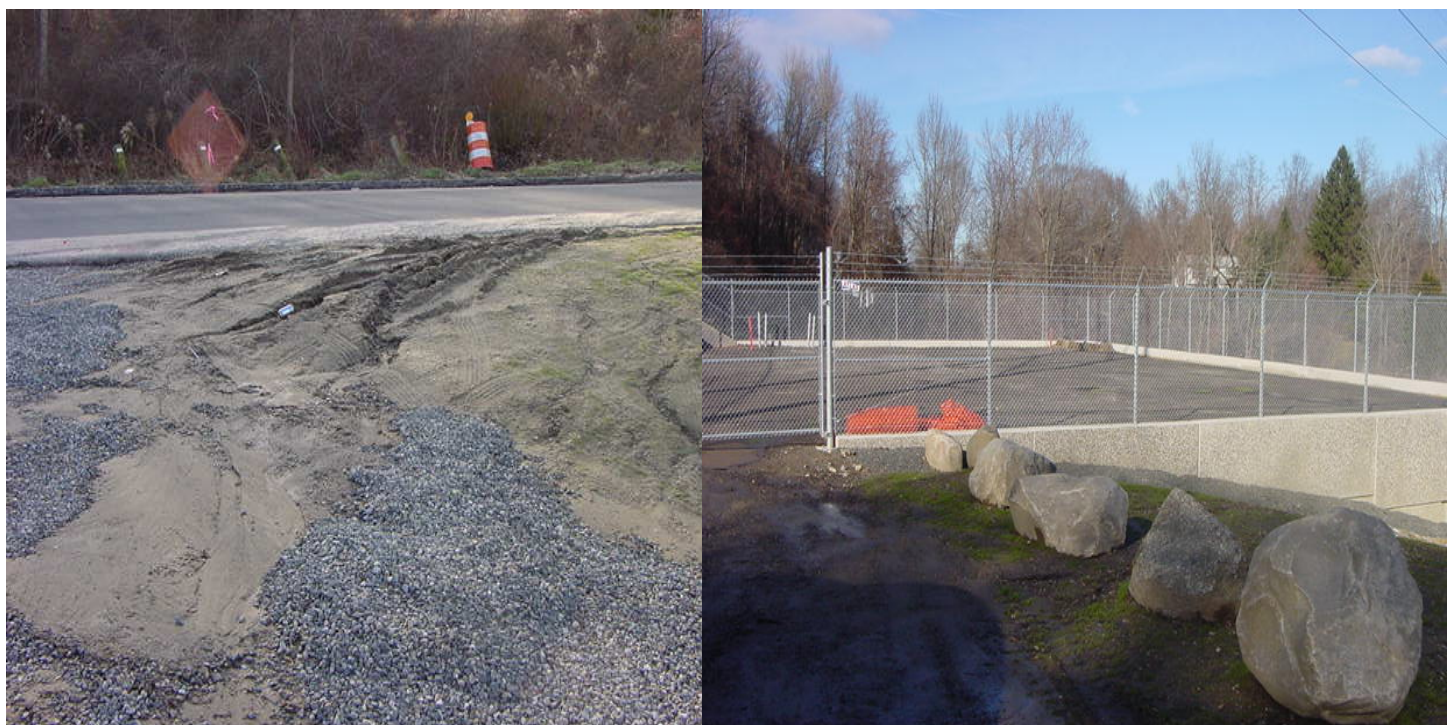
Areas of Inspection	Observation	Recommended Action
Access Roads and Adjacent Roadways	<p>- Hoyts Hill: Access is gained off Hoyts Hill Road. Ruts and erosion remain upgradient of the stone placed at the access point. 12/01-12/30/05.</p> <p>- This disturbed area receives runoff from Hoyts Hill Road which has caused sediment to accumulate within the stone of the access drive. 12/30/05.</p> <p>- Archers Lane: -Grading continues along the access road to the site. The access road was fairly muddy at the time of inspection. 12/30/05.</p> <p>- Norwalk Junction: Sediment tracking was not noted from the gravel pad of the access drive. 12/30/05.</p>	<p>- Ruts should be smoothed out and additional stone installed along this portion to prevent further erosion and sedimentation. Haybales were installed here but did not seem to have much effect. 12/30/05.</p> <p>- None at this time.12/30/05.</p> <p>-Continue to monitor sediment tracking issues and sweep streets if necessary. 12/30/05.</p>

Photo on the left shows the ruts along the edge of the access drive and the sedimentation caused by runoff from the road, over this disturbed area. Photo on the right shows an overall view of the transition station pad. 12/30/05.

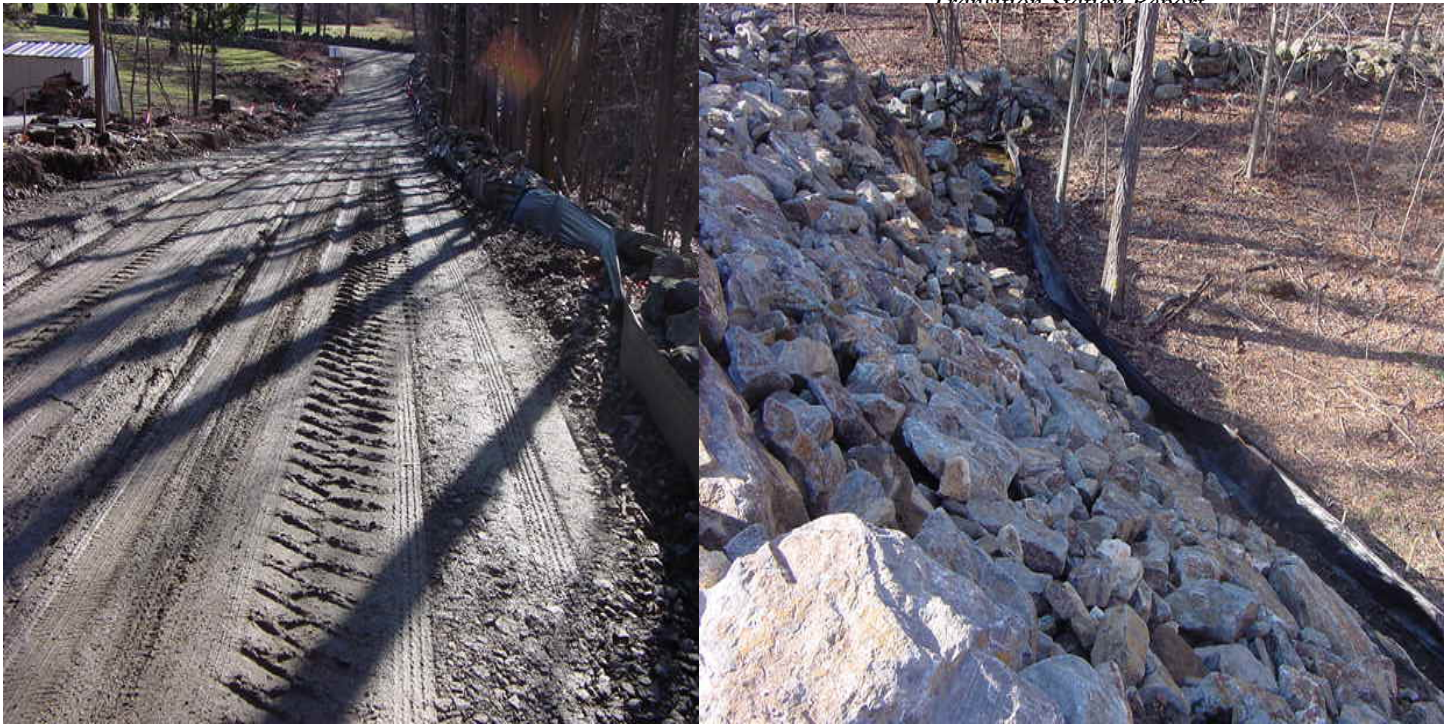
Archers Lane: Photo on the left shows the muddy conditions along the acces drive, looking toward Diamond Hill Road. Photo on the right shows a view along the boulder slope of the access road. 12/30/05.

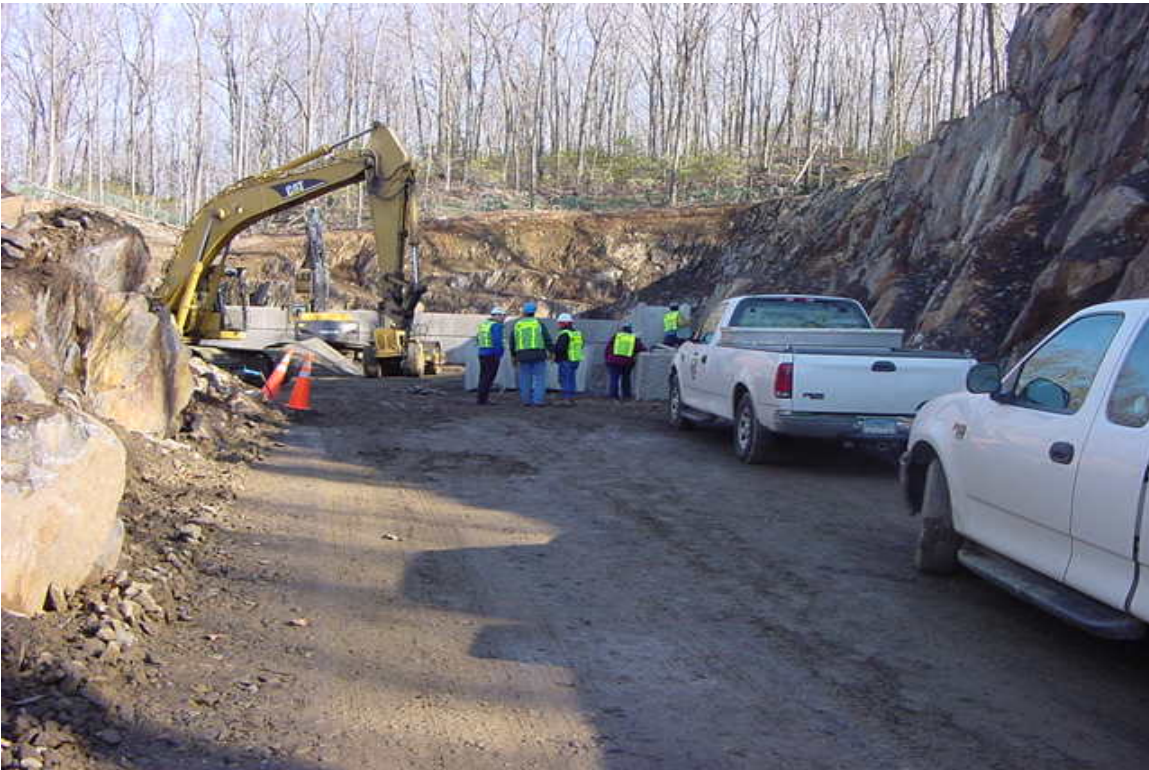
Archers Lane: Photo shows the progress being made on the retaining walls and foundations. 12/30/05.

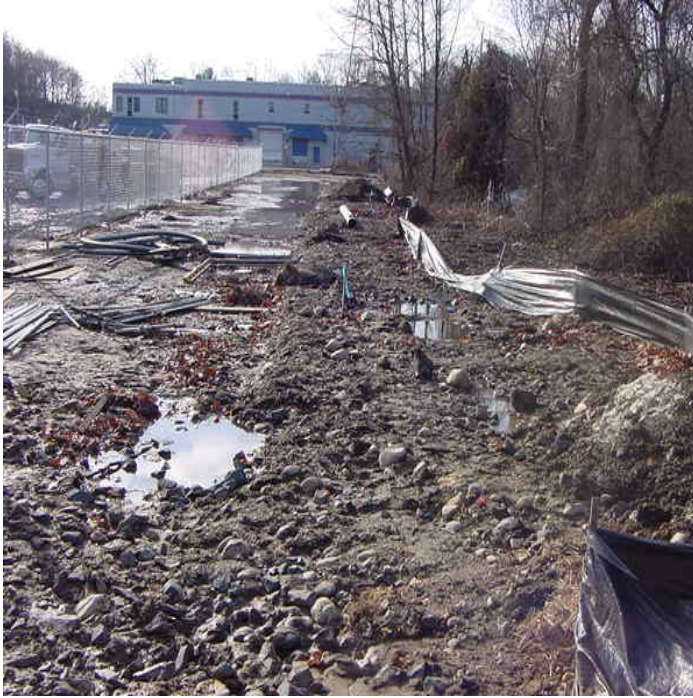
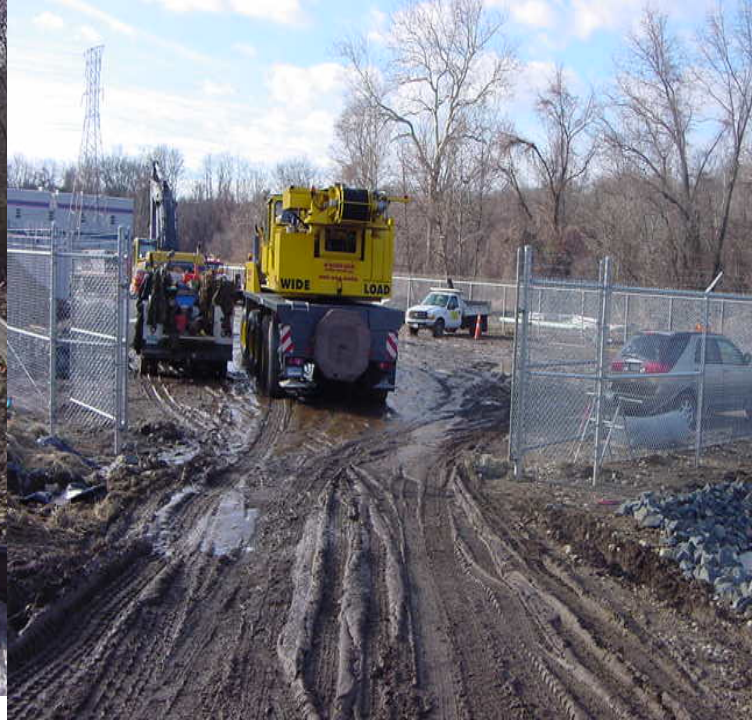
Areas of Inspection	Observation	Recommended Action
	<p>- Norwalk Junction: The majority of the perimeter erosion controls along the Norwalk River are in need of repair, partly due to snow plowing issues and partly due to wear. 12/22-12/30/05.</p> <p>- Flooding may be an issue during extended periods of rain. 11/23/05- 12/30/05.</p> <p>- The outlet of the drainage swale is at the headwall of the wetland area. Turbidity issues were noted here but have not had a significant impact on the river. 12/30/05.</p>	<p>- Perimeter controls still need to be maintained through coordination by the 115kv or transition contractors. 12/22-12/30/05.</p> <p>- Continue to stay within the permitted work. Ground water is extremely high. 12/30/05.</p> <p>-See Erosion Control Section for more details 12/30/05.</p>
State species of concern, threatened and endangered species	- No species of concern are located in these areas of construction.	- N/A

Norwalk Junction: Photo on the left shows the perimeter silt fence along the Norwalk River. The majority of this silt fence is need of repair. Photo on the right shows the newly installed perimeter fence along the station pad and a crane preparing for vault placement for the 345kV section of the project. 12/30/05

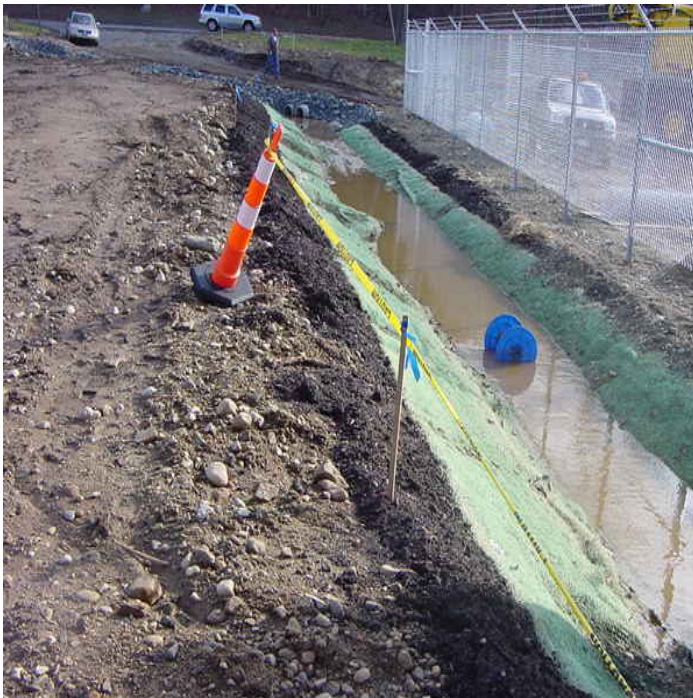
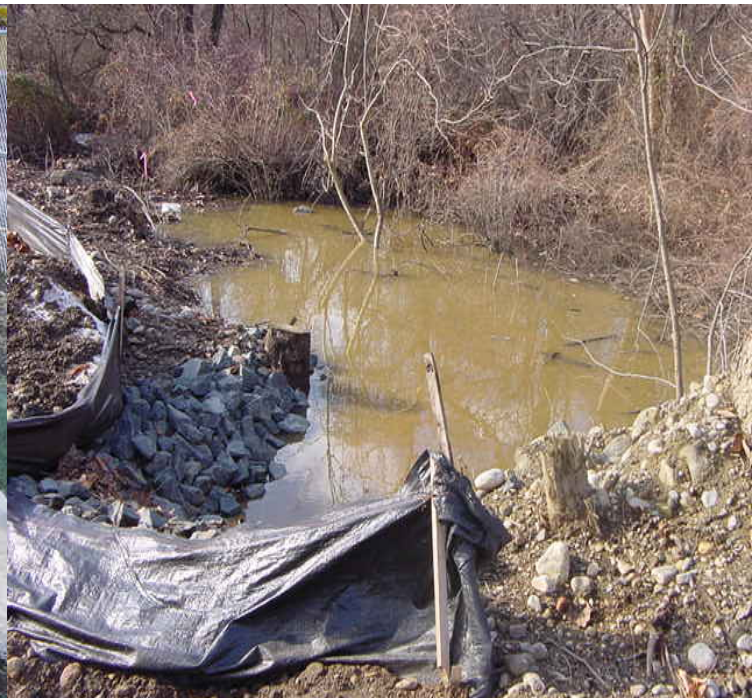
Areas of Inspection	Observation	Recommended Action
	<p>observed at Archers Lane. 12/30/05.</p> <p>- Dewatering associated with 345kv vault excavation also resulted in turbid water in the swale which then discharged into the wetland. The sediment was said to be partially due to a broken filter bag. An intact filter was being used at the time of inspection, but the remaining sediment had not been cleaned resulting in a continued discharge of turbid water into the wetland area.</p>	<p>- None at this time. 12/30/05</p> <p>- Sediment should be cleaned and proper erosion controls installed before dewatering continues. Groundwater here is extremely high and will require dewatering for multiple portions of the project. See erosion control section for recommended actions. 12/30/05.</p>
Blasting	- All blasting is complete at this time. 12/30/05.	- None at this time.
Spills and Material Storage	-No spills or leaks were noted during this inspection 12/30/05.	<p>- Continue to keep all vehicles maintained well (i.e. no apparent fluid leaks) if they will be used or stored on site</p> <p>- Report spills immediately, even if they are being controlled.</p> <p>- Take care not to get carried away and to be vigilant when refueling. Avoid refueling in the areas near the wetlands. Se proper storage for all materials.</p>

Photo on the left shows turbid water within the swale partially as a result of 345kV project related dewatering. Multiple erosive gullies were noted down the edge of the swale as a result of site run-off. Photo on the right shows the area of the swale outlet where turbid water entered the wetland associated with the Norwalk River. This is also likely to be partially a result of 345kV work and partially site run-off. 12/30/05
